Request for Periodic Inspection of DFL7161 Piping and Wiring

DFL7161

Technical Newsletter

#tnl2022-0009e
2 / 3

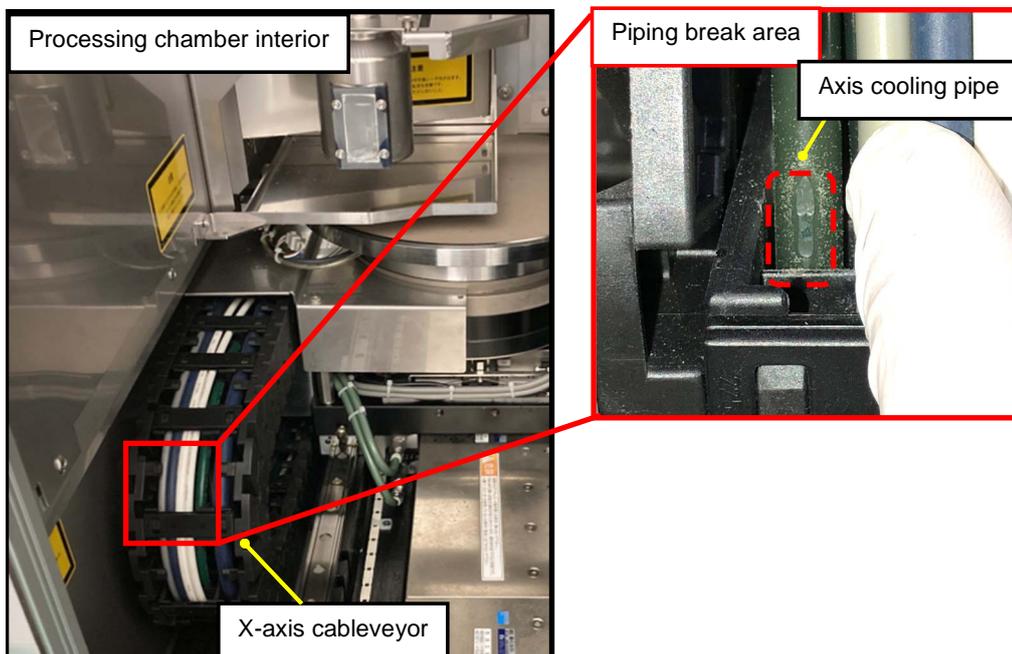
■Example of piping break

The piping and wiring inside the cableveyor are sections that operate frequently compared to other sections, and the environment is more conducive to wear occurring. In particular, the cableveyor used in the DFL7161's X-axis is a section which is operated a lot, and problems such as breaking of the axis cooling water pipe have been reported.

Please perform periodic inspection of the piping and wiring inside the DFL7161 X-axis cableveyor.

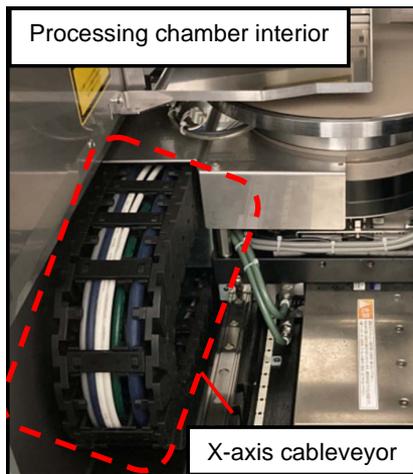
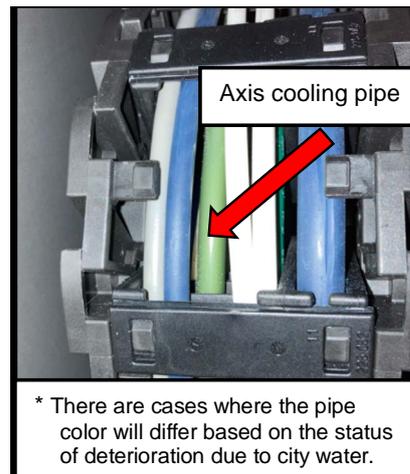
<Applicable section>

Piping and wiring inside the X-axis cableveyor in the processing chamber. The axis cooling pipe is particularly liable to be worn.

Check for cracking and scrapes in the covered section of the piping and wiring inside the X-axis cableveyor. If cracking or scrapes are detected, notify a DISCO sales representative or customer engineer of the wear condition and the applicable piping information. Piping and wiring replacement will be performed by a DISCO customer engineer.

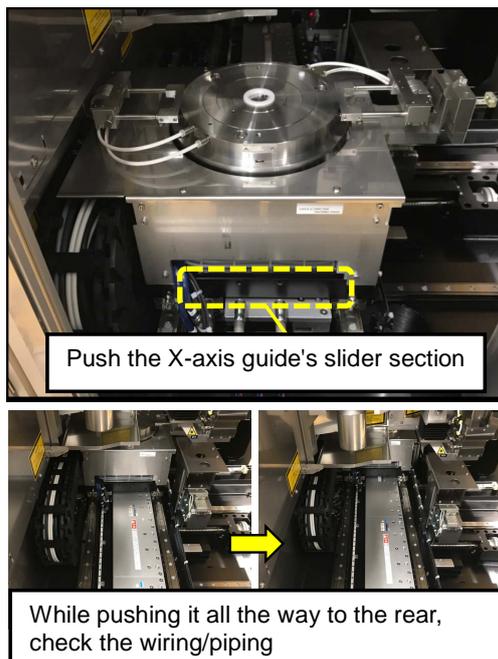
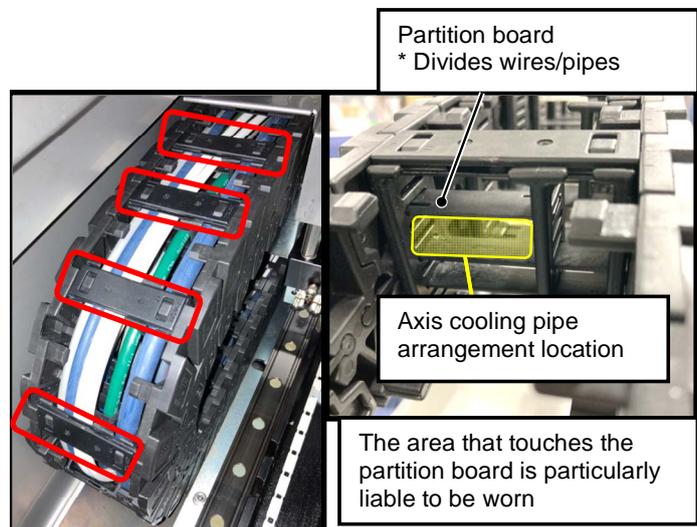
<Inspection procedure>

Turn OFF the machine's power and, while manually moving the slide section of the X-axis guide inside the processing chamber, verify the condition of the piping and wiring inside the X-axis cableveyor. As shown in the cross-sectional view below of the cableveyor interior, there is a partition board dividing the piping and wiring. Since this area is particularly conducive to scrapes, pay particular attention to it when checking.

- It is not necessary to remove the partition board.
