## Investigation of particles in the dicing saw usage environment

Sales Engineering dept.

### Abstract

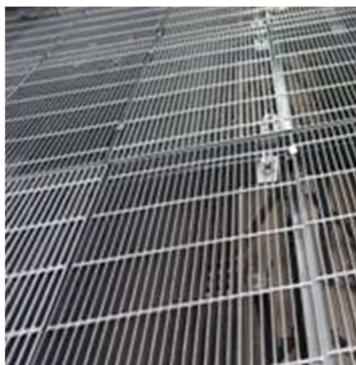
Fig. 1. Grated flooring

In the past, the level of cleanliness required of clean rooms used in the semiconductor assembly process was not high in comparison to the level of cleanliness required in front-end processes. However, with advances in devices and thinner wafers in recent years, there are cases of using clean room environments and structures that meet front-end process standards for the thinning and singulation processes that are directly after the front-end process, and even some cases of grated flooring<sup>(1)</sup> being adopted to increase the laminar flow and reduce the number of particles.

However, in Japan, a country subject to earthquakes, there have been cases in the past where grated flooring has become dislodged and the equipment has fallen over during an earthquake because the optimal grated flooring was not selected and the optimal methods to secure the equipment were not performed, resulting in injury, a large amount of downtime, and costly expenses for repairs and restoration.

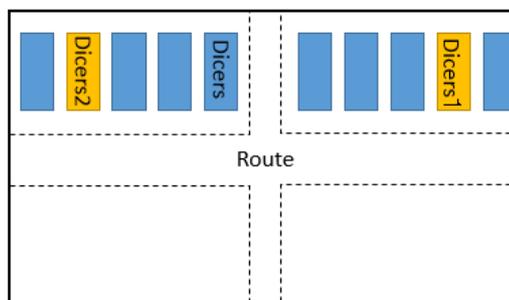
Fig. 3. Placement of measuring equipment

More than ten 300 mm fully-automatic dicers are installed on the normal flooring. Two of the dicers were selected for this experiment. The positions of the measured dicers are shown in Fig. 3.

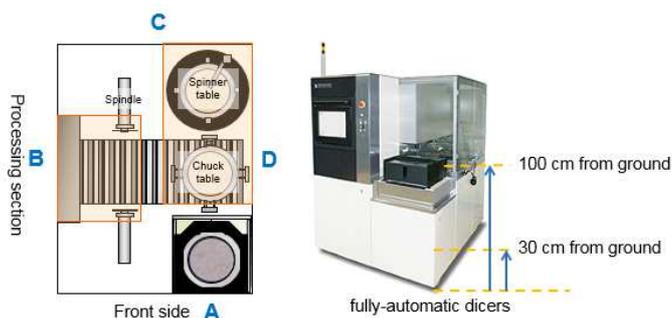
Fig. 4. Places measured on equipment

A total of eight points were measured: points approx. 10 cm from the front, back, left, and right of the dicers at heights of 30 cm and 100 cm. Refer to Fig. 4 for details. At each measurement point, a particle size of 0.5 µm or higher was measured at a conversion volume of 28.3 L, in accordance with ISO 14644-1<sup>(3)</sup>. The measurements were performed while the dicers were being used in fully-automatic operation.

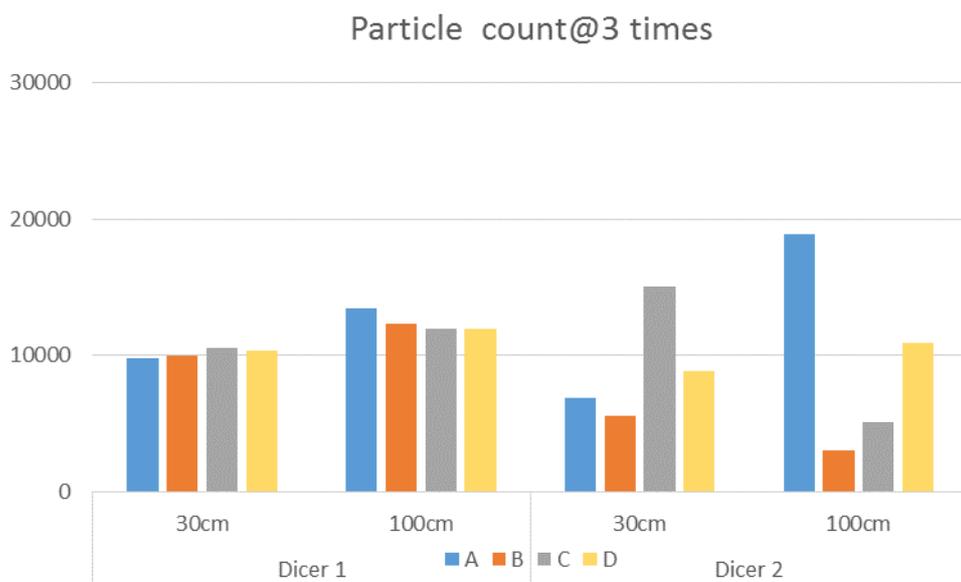
Fig. 5. Total of three measurements around dicers on normal flooring

The total number of particles in each set of three measurements are shown in Fig. 5. A quantity of 30,000 particles or lower can be said to meet the criteria of Class 10,000. For both dicer 1 and dicer 2, the accumulative quantity of particles for three measurements was less than 30,000 in all of the locations. A large amount of particles were observed at point A (front of equipment) at a height of 100 cm for both dicers. In particular, point B (processing section where dicing is performed) had a particularly high amount of particles for both dicers.

Based on the results of this experiment, we have confirmed that if appropriate cleaning is being performed, there is no extreme increase in the amount of particles in a Class 10,000 level environment, even if the dicers are installed on normal flooring. Regarding point B (processing section), where it was easy for particles to be generated, because there were no large quantities of particles indicated for either dicer 1 or dicer 2, we have clarified that it would be effective to install a duct which forces the particles from the processing section toward the exhaust port.

The reason we think that the quantity of particles measured at point A was high is because point A is next to the aisle where many people pass through, and also because it is on the front side of the equipment, which is where the user operates the equipment. We also think that

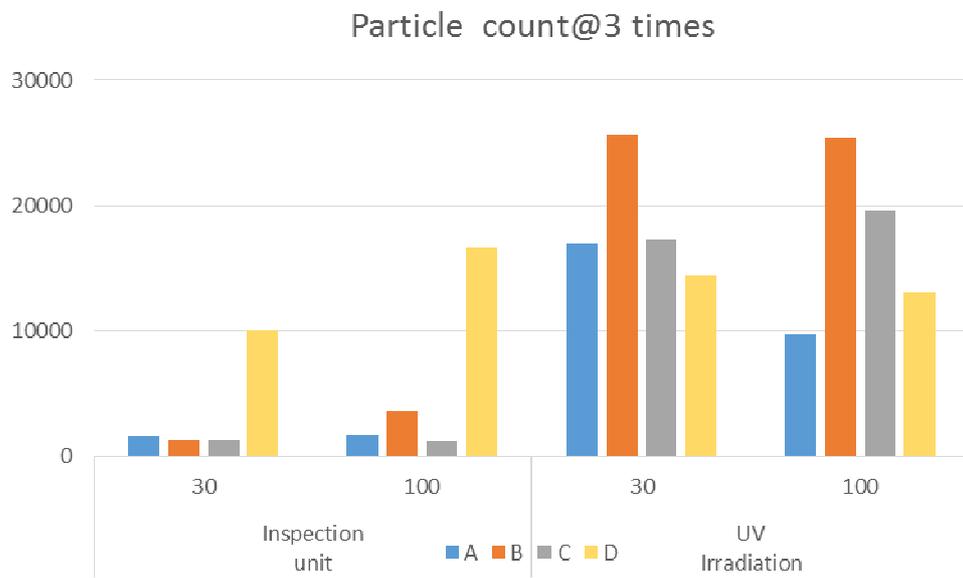
Fig. 6. Total of three measurements around equipment on grated

The area around the UV irradiation equipment and inspection equipment installed on the grated flooring in the same clean room was measured as a reference. Please refer to Fig. 6.

There are other various factors in addition to the flooring composition that are suspected to have generated the particles.
